In late 2003, we tried three hull restorers, applying them to our Neptune 212 (see above). We divided the boat into three sections

### What We Found

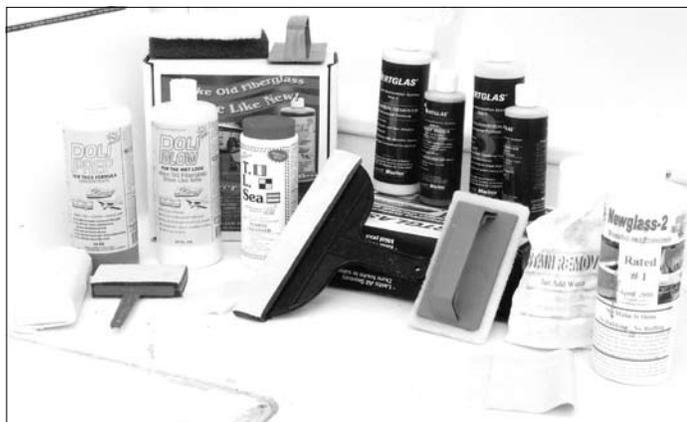
**Below:** *These hull restorers utilize a thin acrylic film coating to bring a high-gloss sheen to a weathered gelcoat. From left to right: Poli Glow, Vertglas and New Glass 2. Right:* *Our initial report published in December 2004 was critical of the Vertglas' straight-edged applicator, which made it difficult to apply the product to radiused areas.*

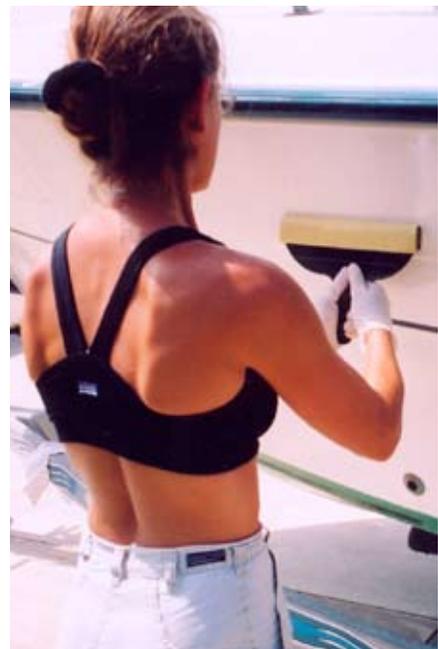
The other sections, those coated with Vertglas and New Glass 2, need some help. The Vertglas sections are spotty. The clear coating has come off on some parts, and the parts where it remains have no visible shine. It appears that most of the New Glass-2 is gone. The stern sections are dull, with no shine.

Vertglas and Poli Glow hull restorers have not changed since our 2003 test. They use the same formulas and their kits come with the same applicators. There have been big changes over at New Glass 2, according to the new owner Thom Goff. The acrylic solids—the stuff that makes the hull shiny—have been upped by 10 percent; the applicator and the labeling and directions have been improved; and the company now offers a cleanser

Recommending Poli Glow is a no-brainer. It's still hanging around after baking in the Florida sun for three years. And as we reported in 2003, it comes with a wide variety of applicators, clear directions, and an effective cleanser. But the apparent improvements over at New Glass 2 call for another test. We'll take them all off and re-apply all three to the same hull sections. ■

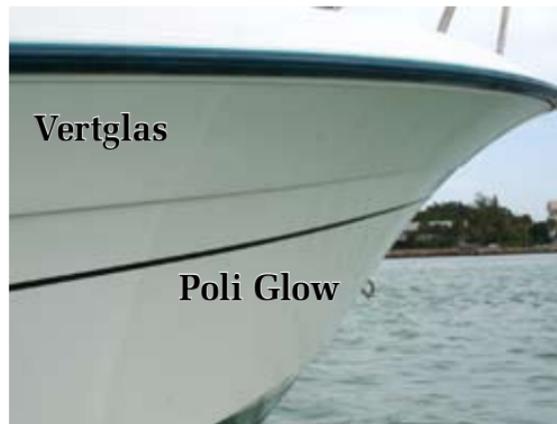
We actually never expected any of the products to last for three years. They are supposed to be re-applied after one or two seasons. But we were pleasantly surprised when we inspected the boat this fall, discovering that one section was actually still “shiny.” The Poli Glow’s acrylic sheen is still clinging to the gelcoat. The bow of the boat looks pretty good.

*Above: The clear sheen of the Poli Glow is still visible on our test boat. The Vertglas coating is spotty.*
